# Daniel Whitten Inspections, LLC

## **BUILDING INSPECTION REPORT # XXXX**

## BUILDING INSPECTION REPORT #1098

Address of Building to be Inspected: Main Street, Upstate, SC

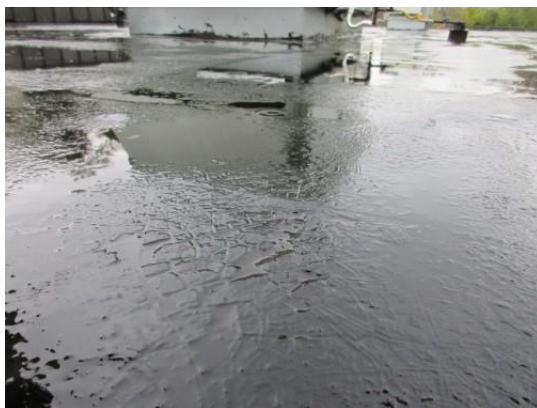
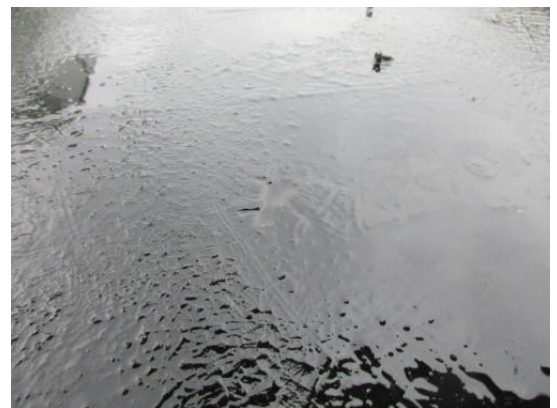
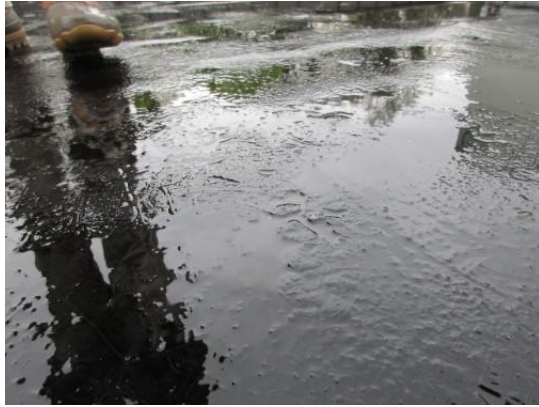
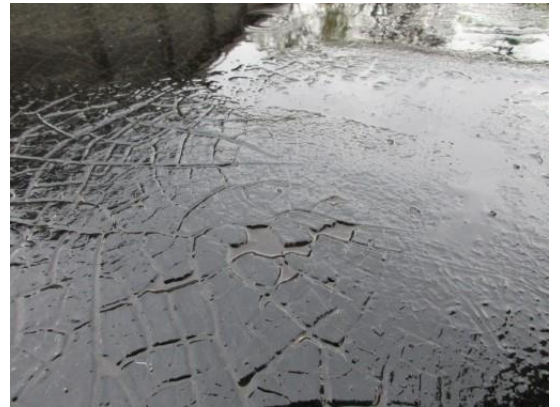
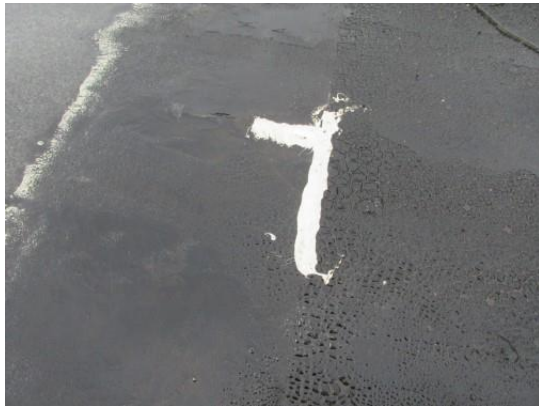
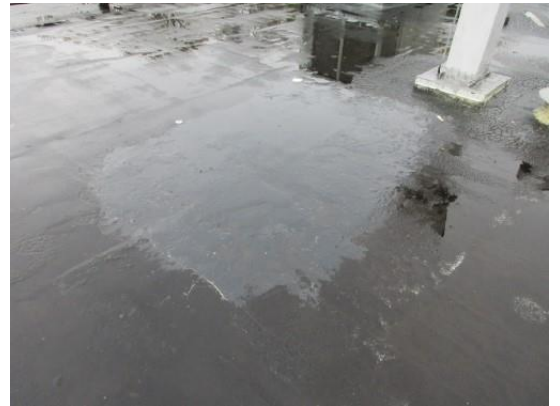
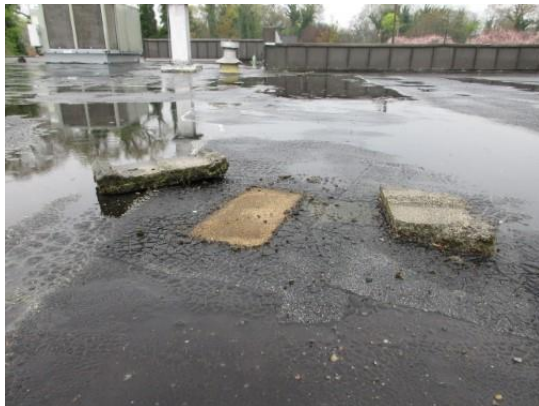
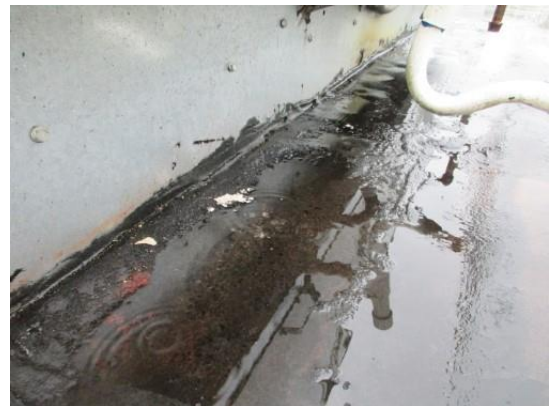
- R.1    **\$\$\$** This roof has been resurface and the newer coating has peeled or delaminated. See examples in photos. This roof has also been patched in areas. See examples in photos. It is time for a new roof covering. Note that various trash and concrete blocks were not moved when resurfacing.

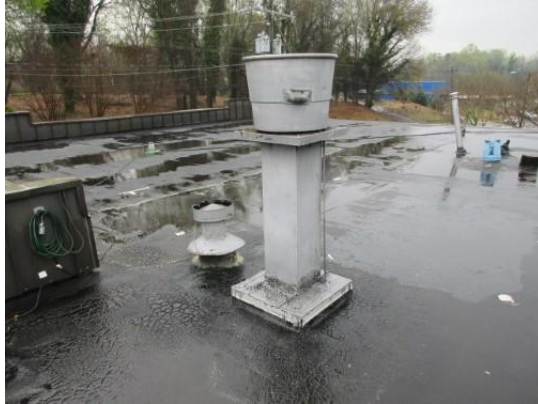
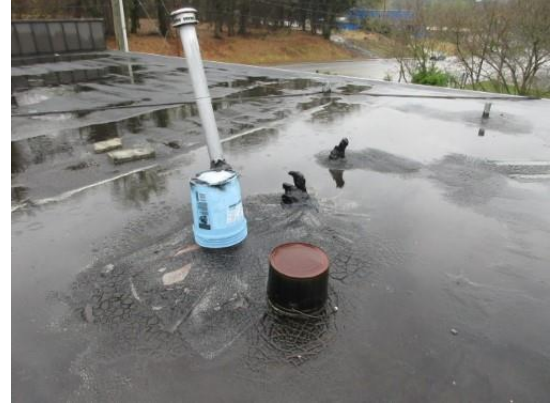
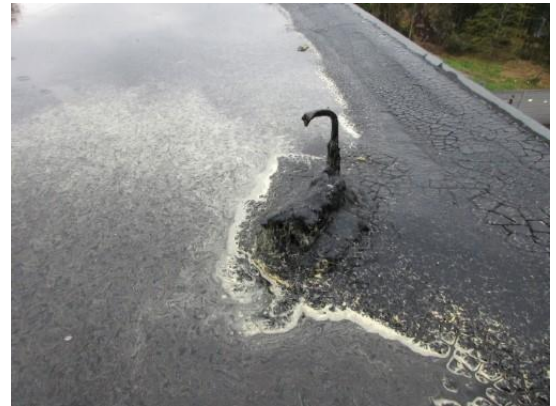
- R.2    **\$\$\$** Recommend removing all of the various abandoned roof penetrations (when replacing this roof covering) for fewer possible leak zones. See examples in photos.

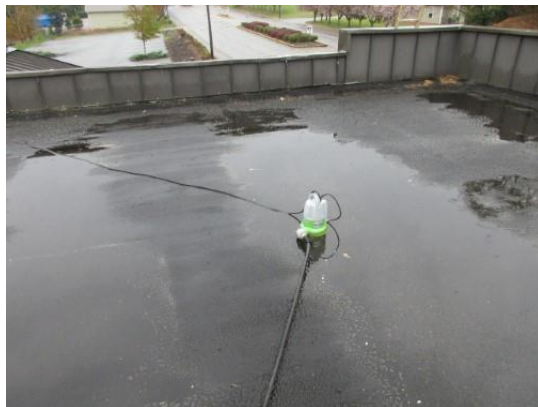
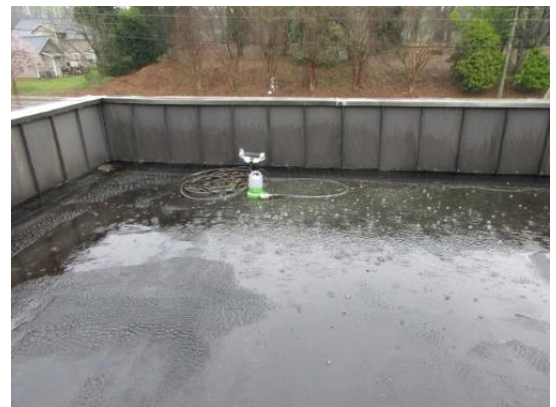
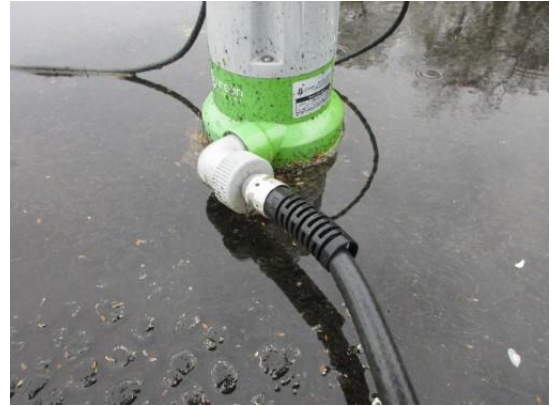
- R.3    **\$\$\$** Two sump pumps have been placed on this roof. If there has been leakage, this is not a professional repair. Note that the discharge has been reduced from 1-1/4 to 3/4. Note also that the other end of the garden hose on the left pump could not be found – do not know where it deposits. Water has ponded in areas of this roof. Recommend employing more carefully placed tapered roof insulation when next replacing this roof covering.

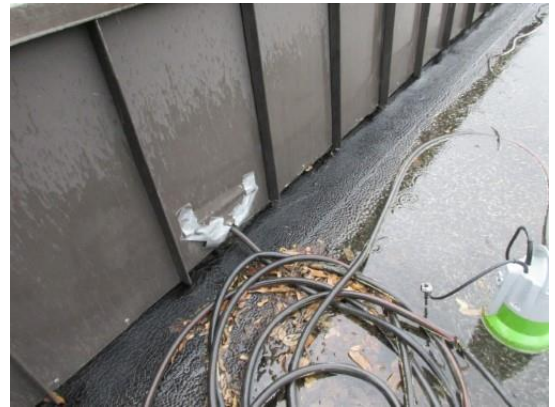
- R.4    \$\$ Metal parapet wall covering has been cut to allow the garden hose passing from a sump pump to drain through.

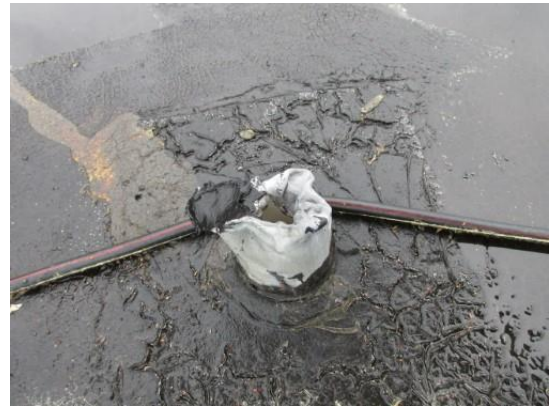
- R.5    \$\$ Flashing sleeve is too large for one of the sewer vent pipes and had to be filled with sealant.

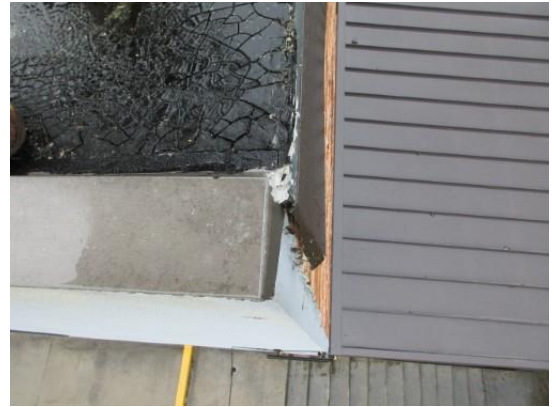
- R.6    \$    Corner trim at the right rear of the roof is loose. It was not determined if this area is flashed.

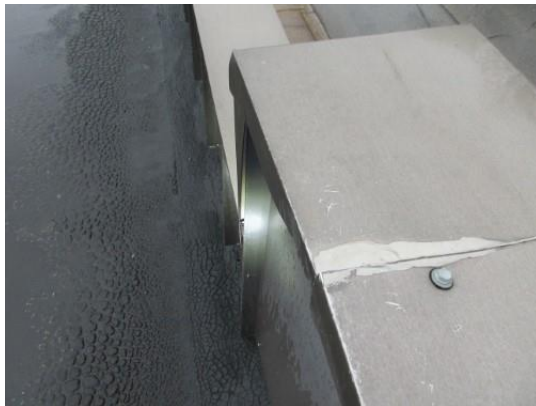
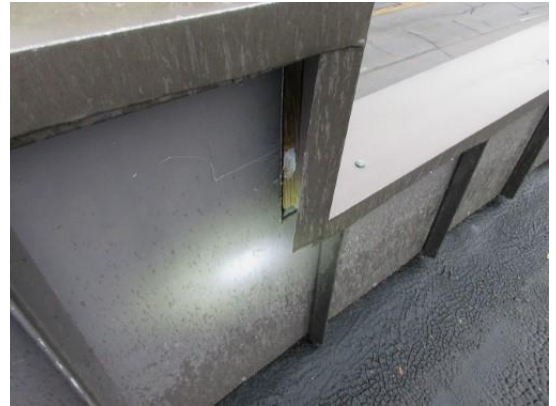
- R.7    \$    Flashing is incomplete at the front left corner.

- R.8    \$\$    There are openings in the front parapet wall through which blowing rain may enter.

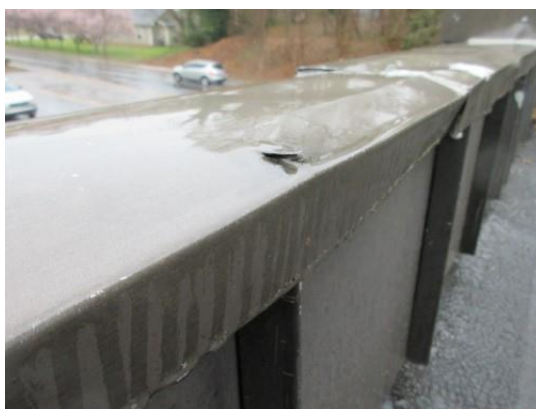
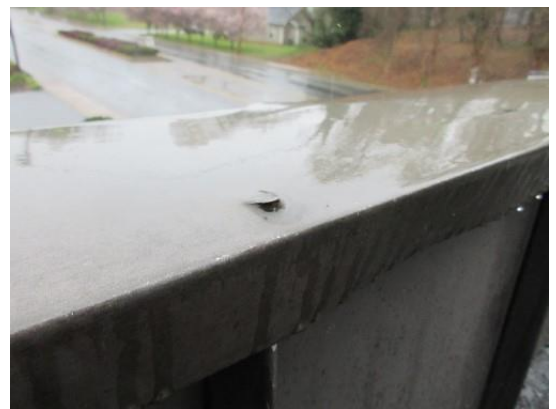
- R.9    \$\$    Metal coping has torn over some of the concealed fasteners. See examples in photos.

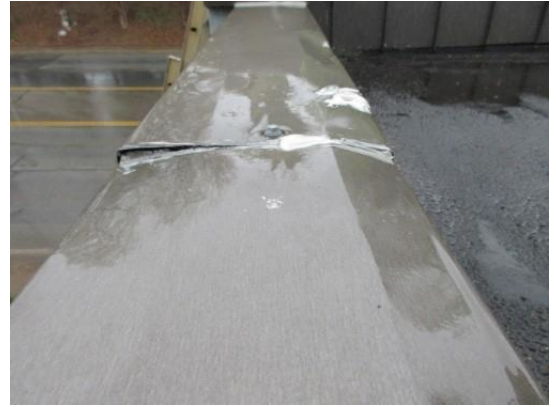
- R.10 \$\$ Joints/caulk in the coping have separated in areas. See example in photo.

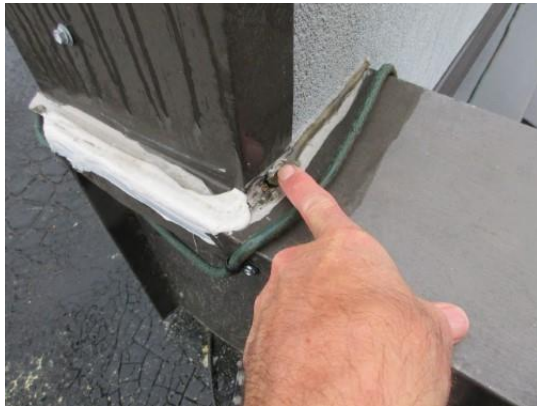
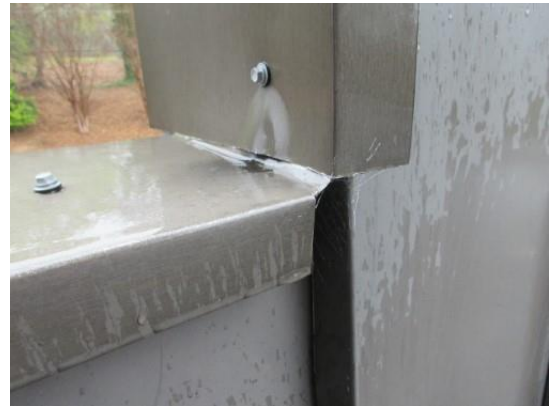
- R.11 \$\$ One or more lower pieces of metal coping not extend up behind vertical pieces. See left photo. Right photo shows correct flashing of this coping.

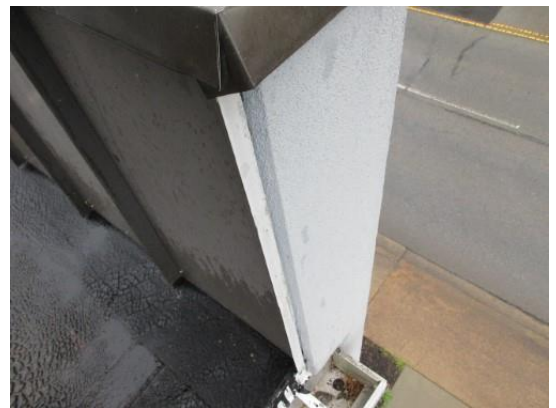
- R.12 \$\$ Flashing is missing at the front left corner where metal meets stucco on the parapet wall.

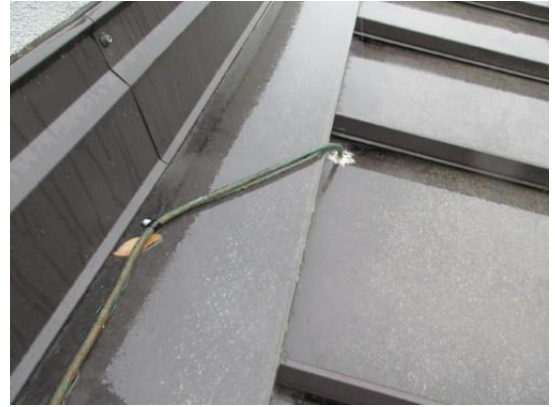
- R.13    \$\$    A cable passes through the front porch ceiling. Caulk on this hole should not be relied upon to prevent leakage.

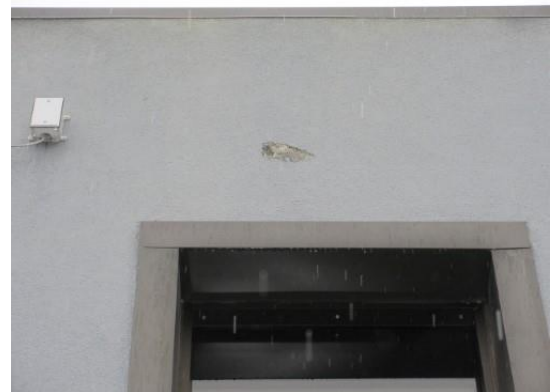
Damaged stucco was observed especially at the right side. See example in photo.

- X.1 **Dig Deeper** Exterior surfaces covered with stucco require a separate, special inspection, usually including drilling small holes to test for moisture. This is not a stucco inspection. Any deficiencies observed are listed as a courtesy. We strongly recommend you consult a qualified, experienced stucco inspector for full stucco inspection. Conditions in this area are unknown and are specifically excluded from this inspection and report.

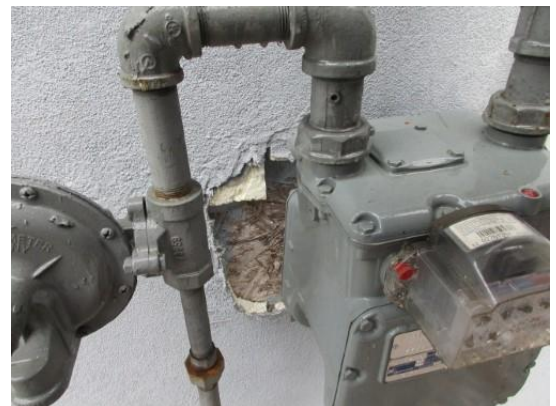
Incomplete stucco was observed at the left side gas meter area.

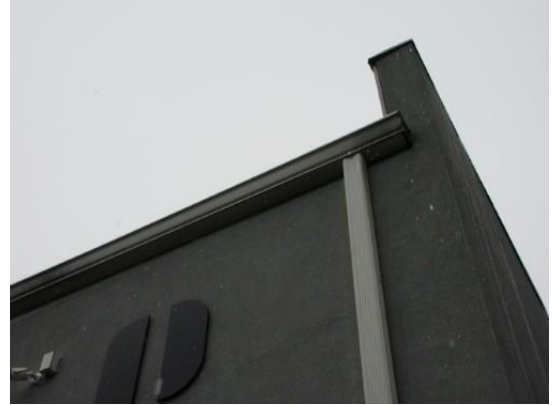
Stucco does not appear to be flashed to the area behind the gutter at the left side.

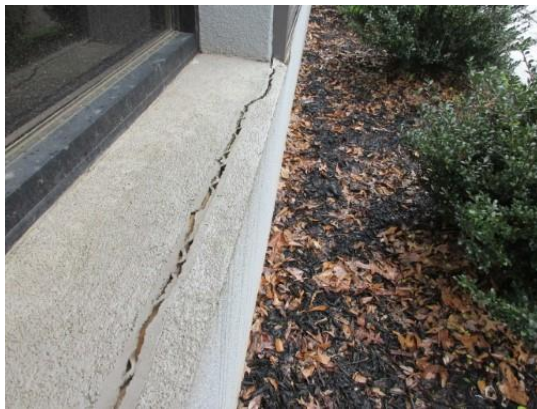
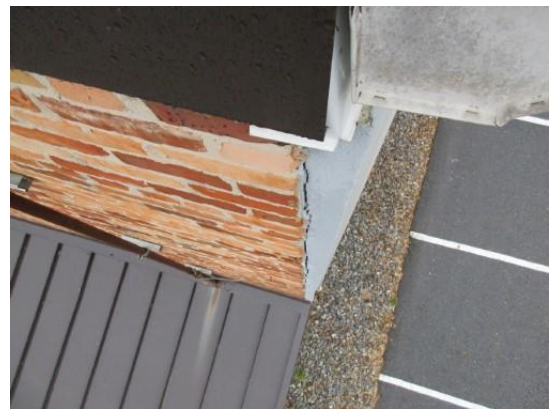
Stucco has cracked/separated in areas, especially at the left rear corner and a front left window area.

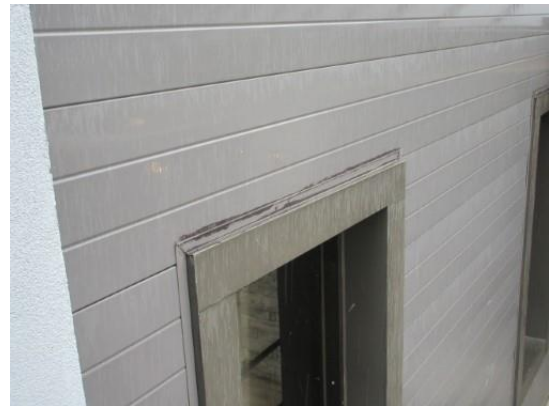
X.2    \$\$    Caulk or tar has been applied to trim over the exterior of some of the windows, usually an unprofessional attempt to remedy roof leakage. Request a qualified contractor to install professional repair (probably flashing). See related remarks below.

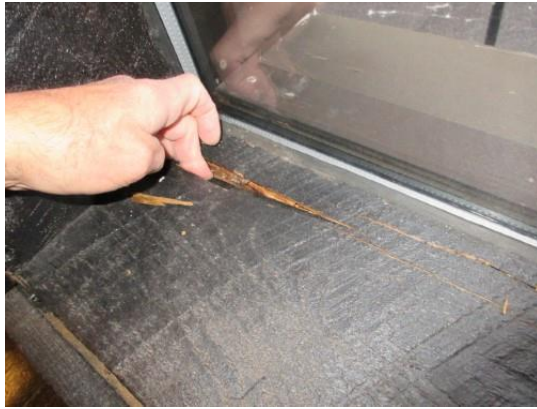
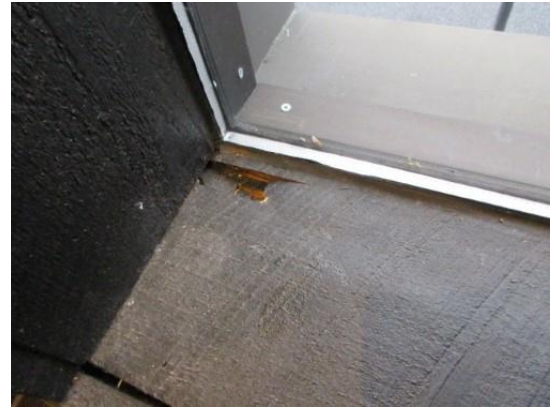
- X.3     **\$\$** Damaged wood was observed especially at, but not necessarily limited to various interior window sills, indicating past leakage. See examples in photos. All areas were dry when tested with an electronic moisture meter. Damaged areas will tend to be more apparent after probing. There may be concealed damage. Monitor for leakage and repair as needed. See related remarks above.

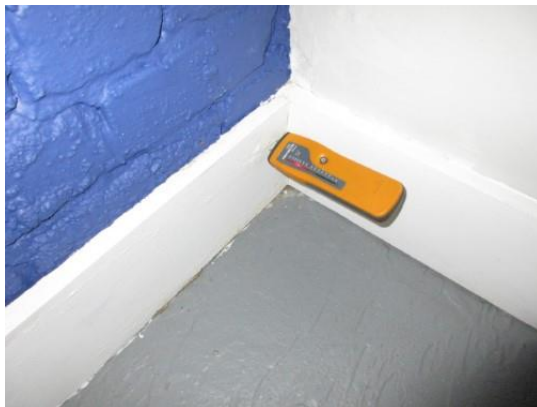
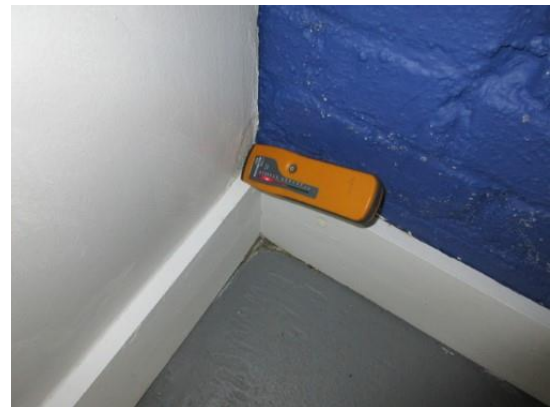
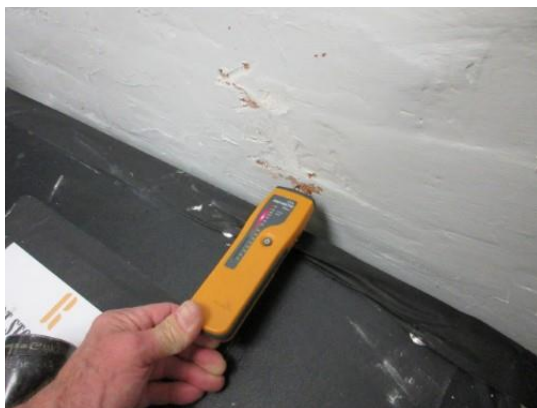
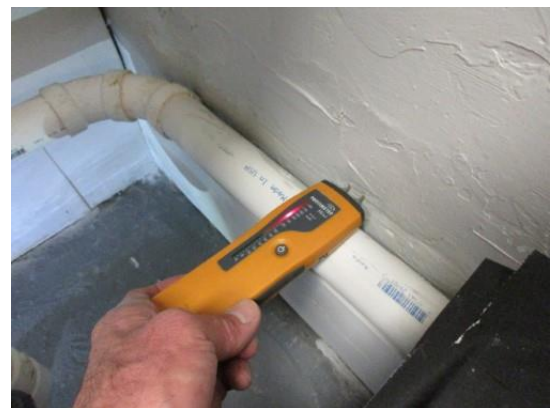
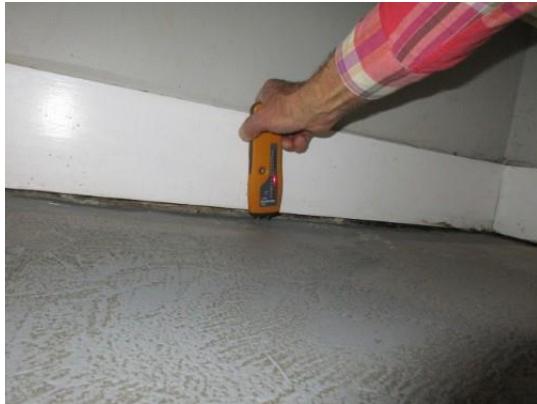
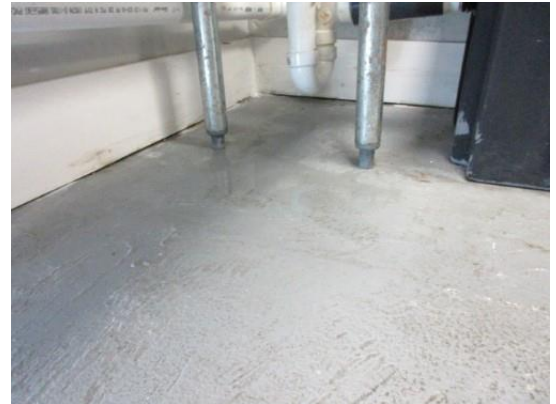
- X.4     **\$\$\$** Puddles on the basement floor and wet wall brick and wall covering, especially at the left side, indicate continued water seepage into this finished basement area. See examples in photos. Consult a professional basement drying company for evaluation and repair.

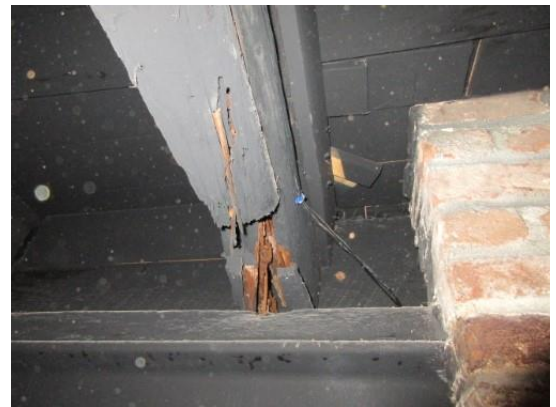
- X.5     **\$\$** A ceiling joist near the top of the stair at the main level area is moisture damaged and needs repair. There may be concealed damage. This area was dry when tested with an electronic moisture meter. Monitor for continued dampness and repair as needed.

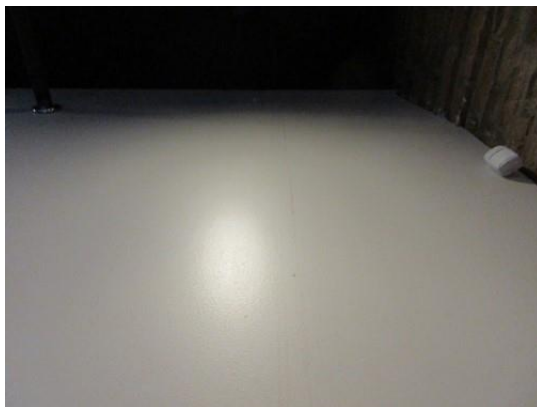
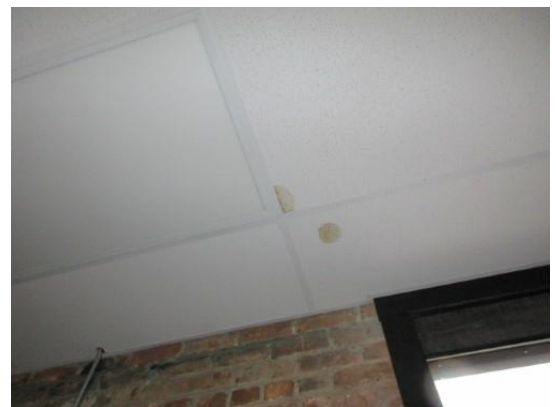
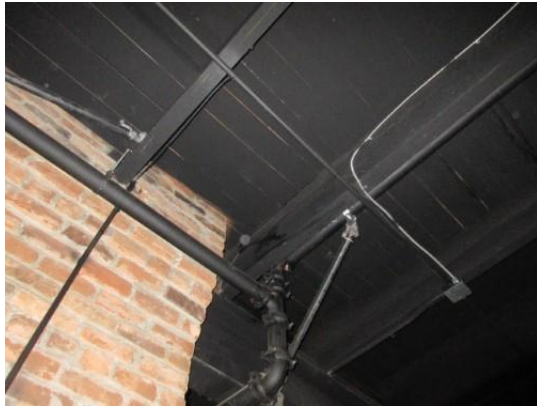
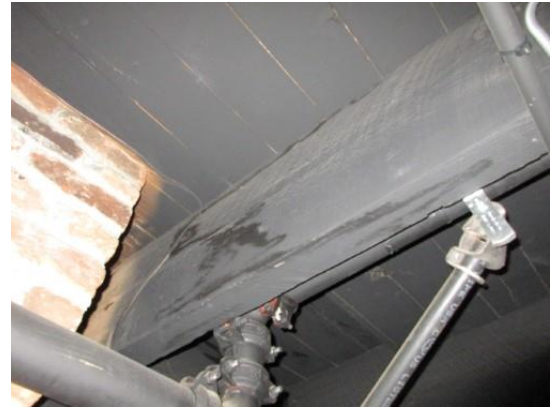
- X.6     **Dig Deeper** Moisture stains on various ceilings and on the wall outside the main level left rear storage room tested as being dry with an electronic moisture meter. See examples in photos. Recommend asking the owner if there has been leakage and if the leak(s) has been effectively repaired. Recommend monitoring for continued leakage and repair as needed. There may be concealed damage.

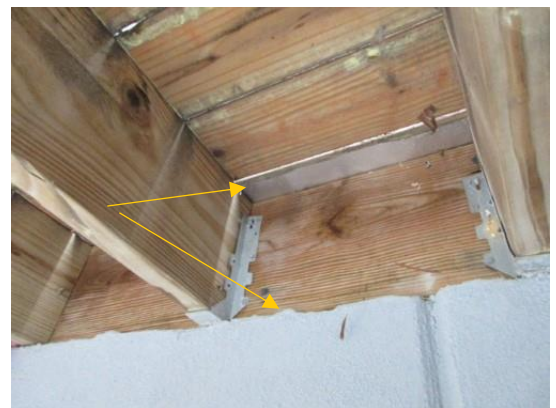
- X.7     \$\$ Flashing is installed between the left deck framing and flooring but does not have a drip cap to help prevent water from being redirected back across the bottom of the flashing towards the building. There is also no flashing installed between the bottom of the left deck floor frame and wall. There may be concealed damage.

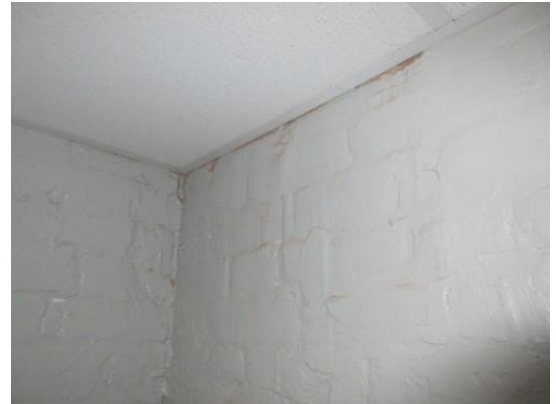
- X.g A pink-coloured dust was observed in areas on edges of the interior brick. See example in photo. This is not unusual for unfired brick which tends to deteriorate over time, especially when regularly exposed to moisture. This does not appear to be causing a problem at present.

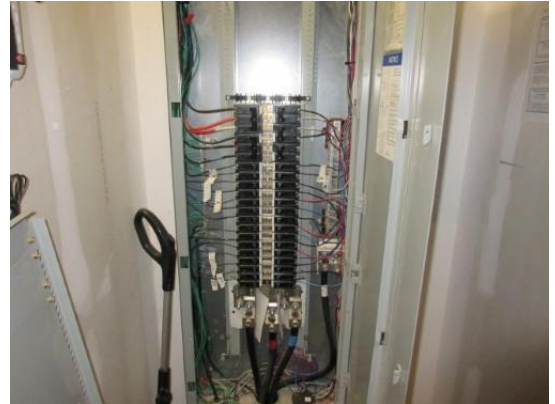
- E.1 **SAFETY \$\$** A 30-amp circuit breaker in the branch electrical panel is large for its #12 wire and may not trip when there is a fault in the circuit.

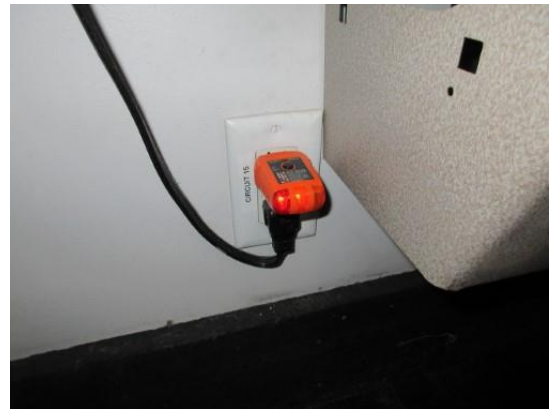
- E.2 **SAFETY \$** Hot and neutral wires are reversed at the water chiller receptacle.

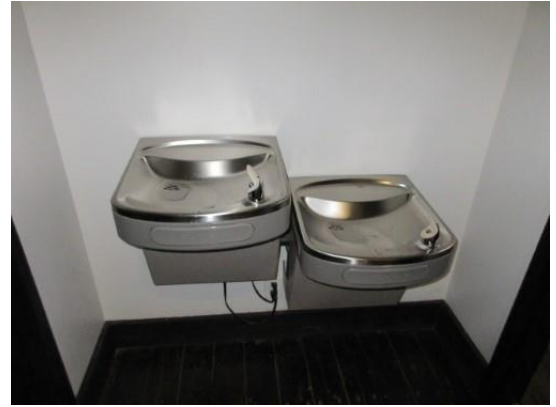
P.3      \$\$ The water chiller compressors did not operate.

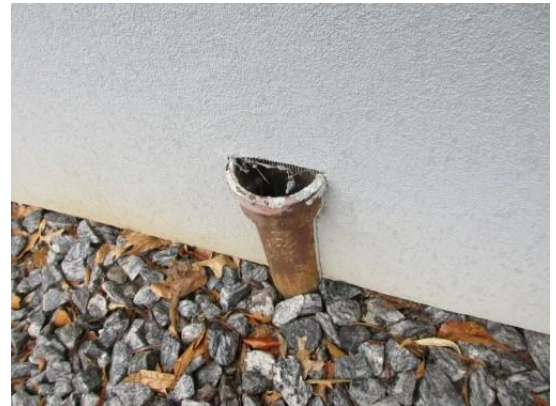
P.5      \$\$ There is an open waste pipe at the left side exterior.

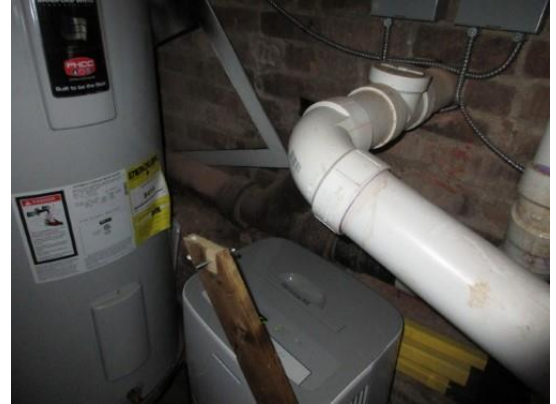
P.c Some of the waste piping has been replaced. Some of the original cast iron waste piping remains. See example in photo. This older piping tends to clog and deteriorate over time. Expect to have to replace in future.
