# Daniel Whitten Inspections, LLC

## **BUILDING INSPECTION REPORT # XXXX**

Inspection Address:

Fortune Drive

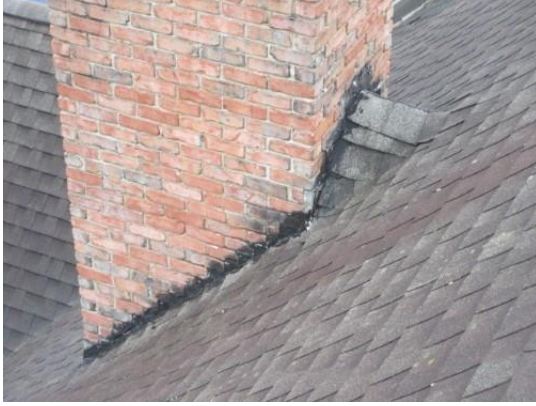
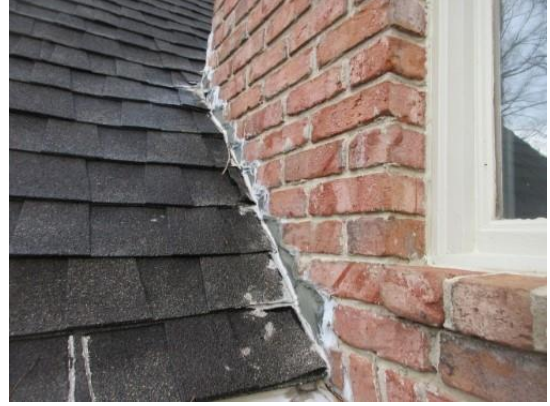
- R.2    **\$\$\$** Caulk and/or tar has been applied to roofing material and flashing especially at the left of the front entrance and around the front chimney, usually an unprofessional attempt to remedy roof leakage. There is active leakage at both of these areas now. See related remarks in the Attic and Crawlspace sections.

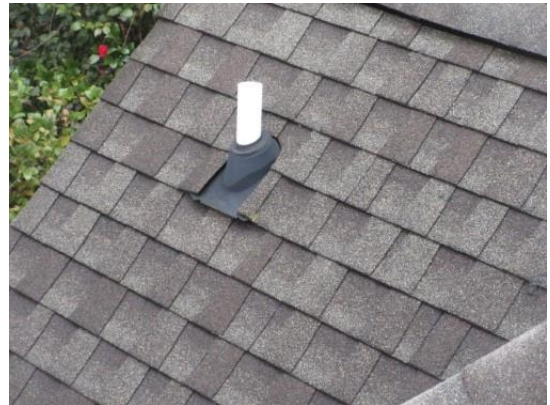
- R.3    **\$** An edge shingle is damaged at the front gable over the garage.
- R.4    **\$** A front left sewer vent pipe boot has lifted from the roof.

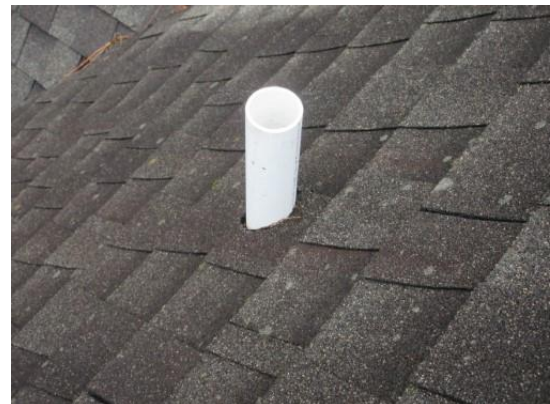
- R.5    **\$\$** A front left pipe (probably for the tankless water heater) lacks a boot. See related remarks in the Attic section.

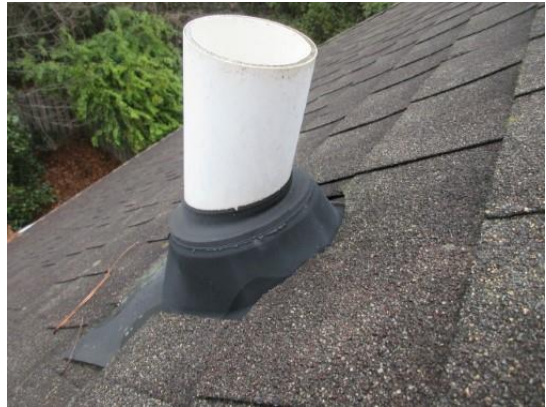
- R.6    \$\$ The rubber boots are damaged on some roof penetration pipes. See example in photo.

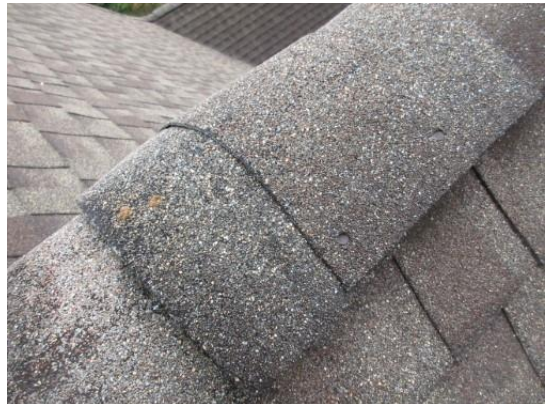
- R.7    \$\$ Some ridge shingles and sewer vent pipe boots have exposed nail heads. See example in photo.

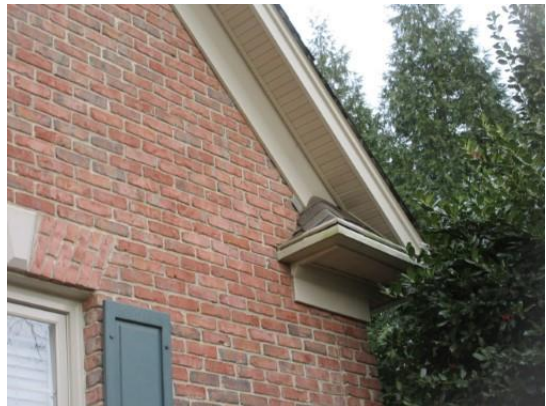
- R.8    \$\$ Shingles are not flashed to the brick at the roof returns. See example in photo.

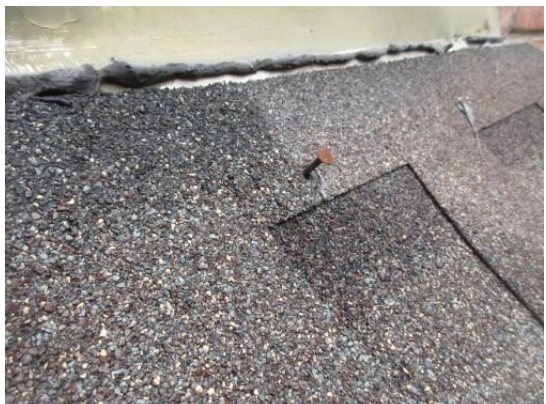
- R.9    \$ A nail has come loose over the garage door area.

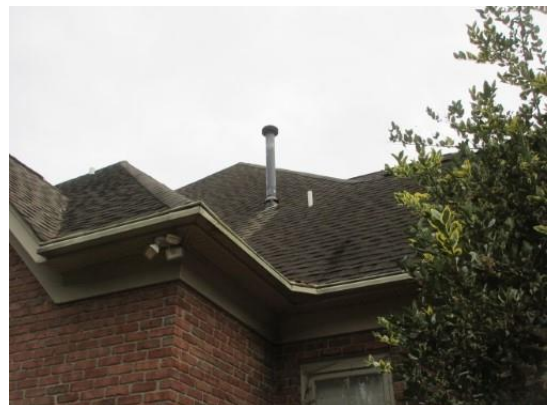
- R.d This metal ridge vent over the rear porch area is very likely to leak, especially since fasteners pass through the trough where water flows. Caulking the fasteners usually helps, but recommend replacing these ridge vents with shingle-over ridge vents. This may be a large expense.
- R.e Recommend removing this abandoned flue when next replacing this roof covering, for one less roof penetration.

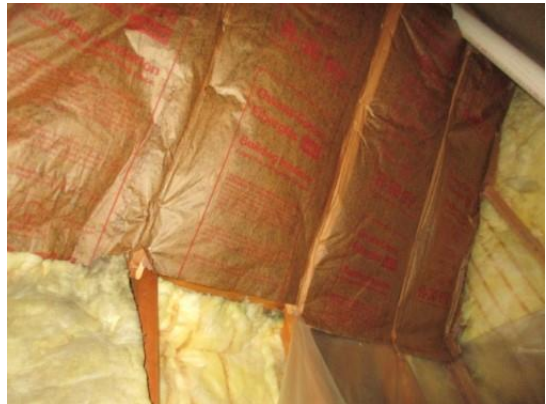
A.2    **SAFETY \$\$** Batt insulation vapor barrier is exposed at a right rear knee wall attic. Manufacturer's instructions on the vapor barrier indicate this barrier is not permitted to be left exposed due to flammability.

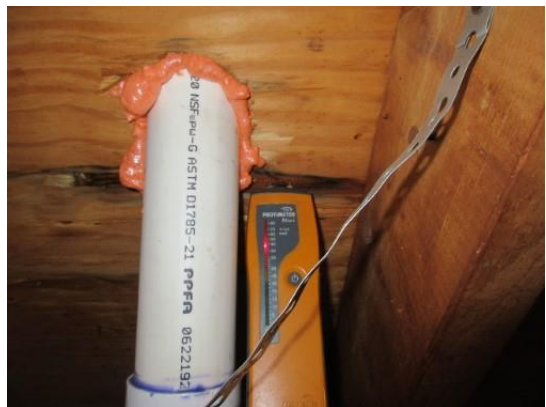
A.3    **\$\$** Roof sheathing especially at the tankless water heater flue area is moisture stained. This area was wet when tested with an electronic moisture meter, indicating active leakage. See related remarks in the Roof section.

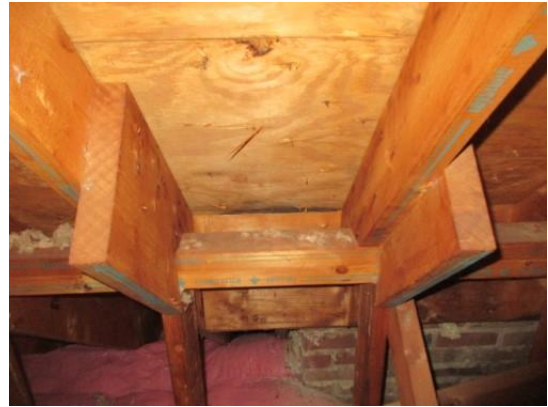
- A.4    **\$\$** Roof sheathing especially at the front chimney area is moisture stained. This area was damp when tested with an electronic moisture meter, indicating active leakage. See related remarks in the Roof section.

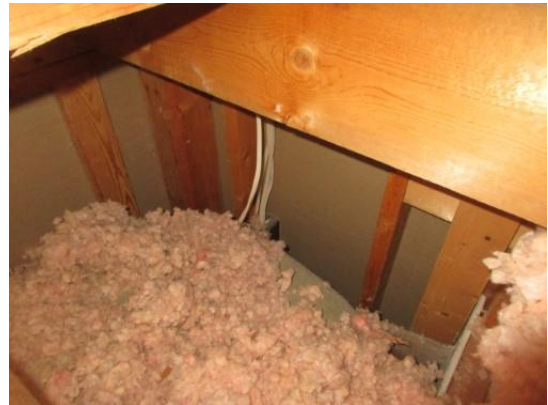
- A.5    **\$\$** There is an opening in the ceiling or between walls at the right of the HVAC equipment through which attic air spills next to uninsulated walls. This area should be covered/sealed with appropriate fire blocking material where applicable and insulated for improved energy efficiency.

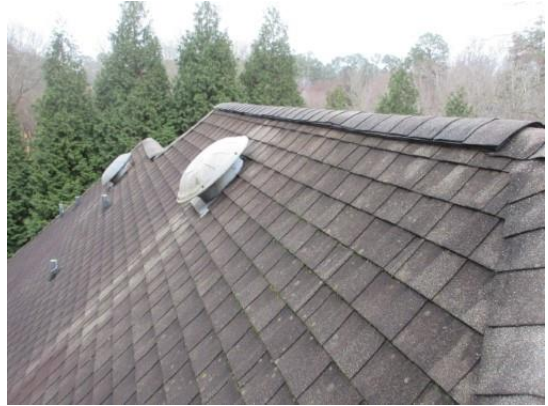
A.c Power fans have been installed in the roof near ridge vents. The fans will tend to pull air from the ridge vent rather than from the soffit. Recommend disconnecting and removing the fans when next replacing this roof covering. This attic is naturally ventilated by soffit and ridge vents. It is not logical to spend money on the fan, installation and operation, in order to save through especially ineffective mechanical ventilation.

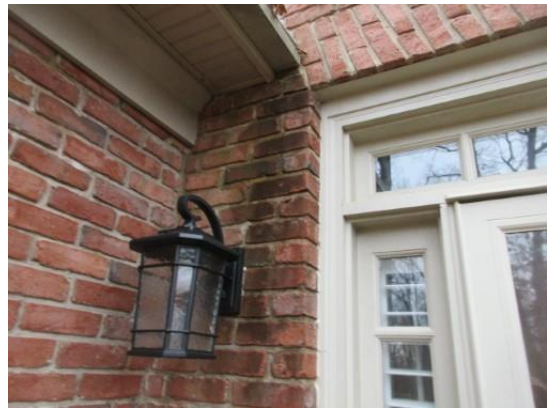
- X.1     \$\$ The masonry siding especially at the left of the front entrance is stained and wet, indicating water repeatedly flows to this area. See example in photo. Repeated saturation of masonry may lead to condensation forming, and even leakage, behind the masonry. There may be concealed damage. See related remarks in the Roof and Crawlspace sections.

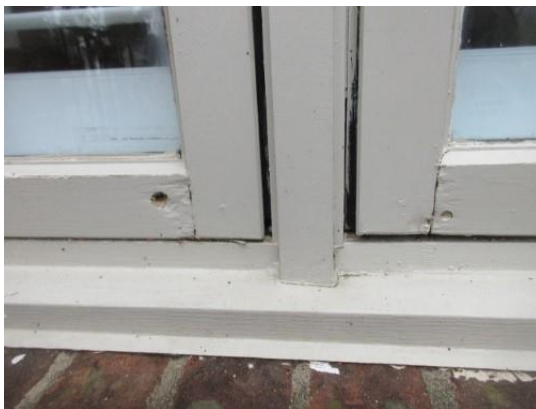
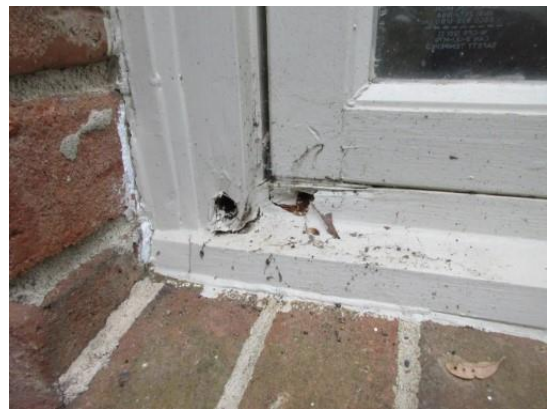
- X.2     \$\$ Damaged wood/material was observed especially at, but not necessarily limited to, lower front triple windows; trim and sill at the lower left window. See examples in photos. Damaged areas will tend to be more apparent after probing. There may be concealed damage.

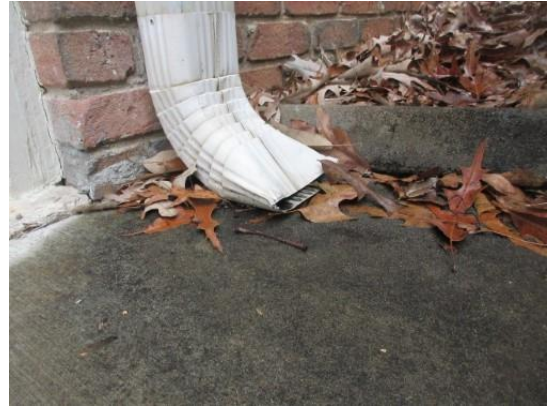
X.3      \$ A downspout at the garage door area is damaged.

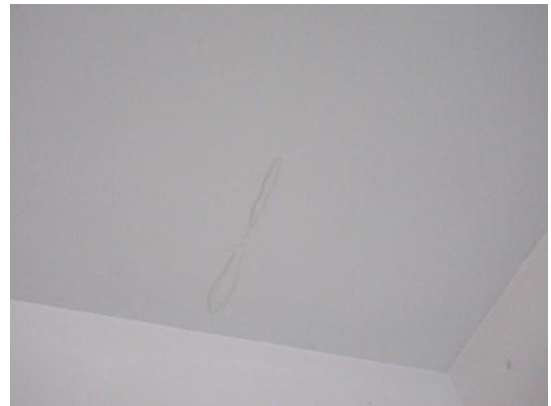
G.2 **Dig Deeper** Moisture stains on the garage ceiling were not within reach to test with an electronic moisture meter. Recommend asking the owner if there has been leakage and if the leak(s) has been effectively repaired. Recommend monitoring for continued leakage and repair as needed. There may be concealed damage.

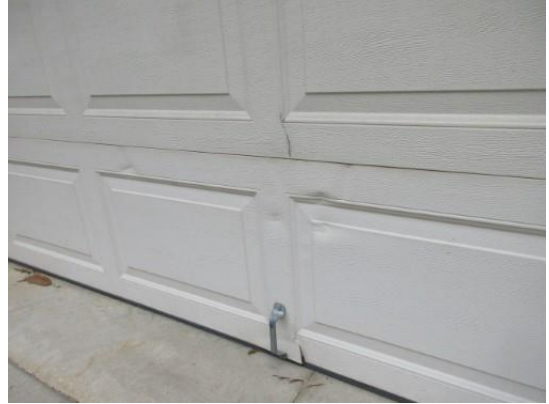
- G.b The bottom panels of the overhead garage door are cracked and damaged. This does not appear to be causing a problem. Repair as desired.

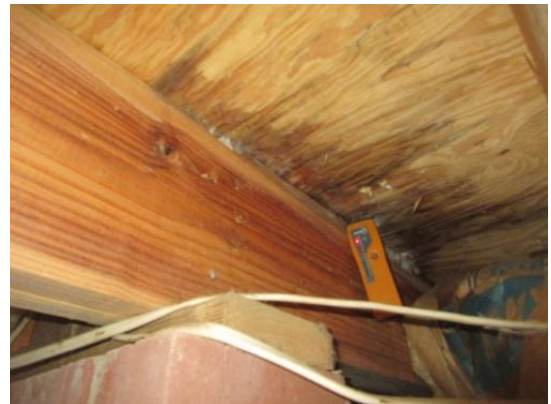
- C.1    \$\$    Floor and framing especially at the left of the front entrance area is moisture stained. This area was wet (90%) when tested with an electronic moisture meter, indicating active leakage, probably from the intersecting valley above this area. Stains indicate this shower has leaked in the past. See related remarks in the Roof section. There may be concealed damage.

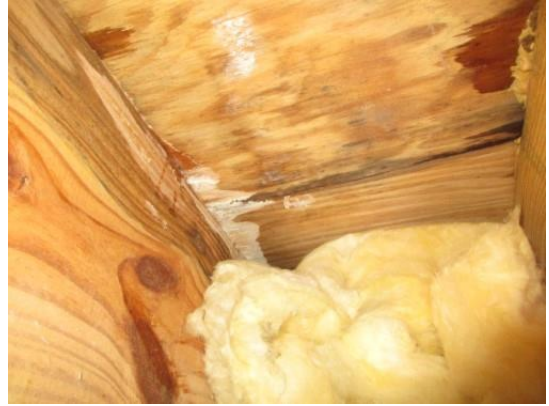
C.2    \$\$\$    Floor and framing especially beneath the master bathroom shower area is moisture stained. This area was wet when tested with an electronic moisture meter, indicating active leakage, usually from a faulty pan beneath the shower tile. Stains indicate this shower has leaked in the past. There may be concealed damage. See related remarks in the Plumbing section.

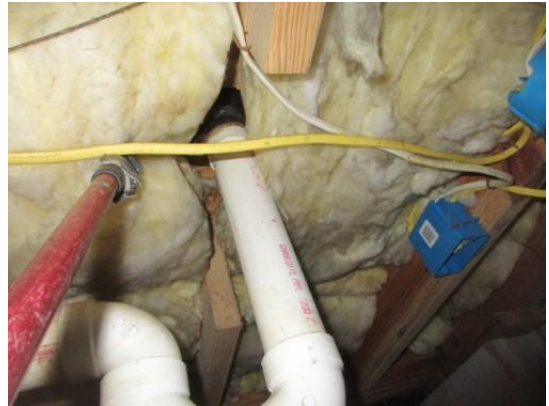
C.3    \$\$    A floor joist has been cut to make room for the master bathroom shower waste pipe.

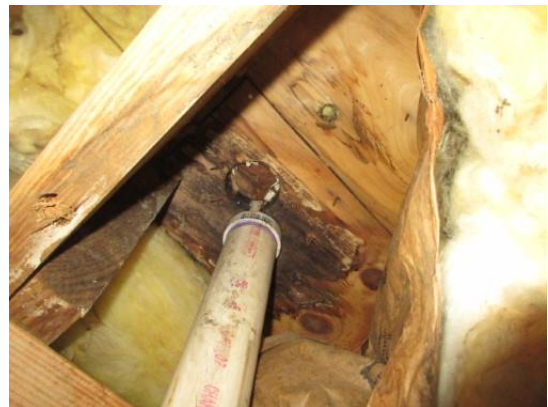
C.f Floor and framing especially beneath the under-counter ice maker area is moisture stained. This area was dry when tested with an electronic moisture meter. Monitor for continued dampness and repair as needed.

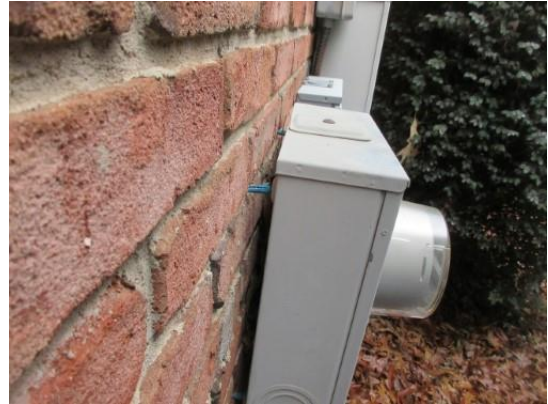
- E.2 **SAFETY \$\$** The electrical meter has started to pull from the house.

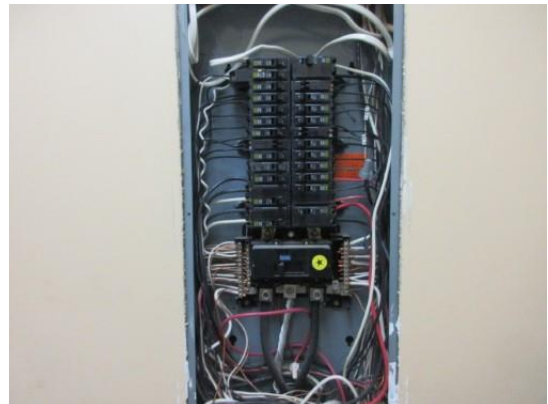
- E.3 **SAFETY \$\$** A 20-amp circuit breaker in the laundry electrical panel is large for its #14 wire and may not trip when there is a fault in the circuit.

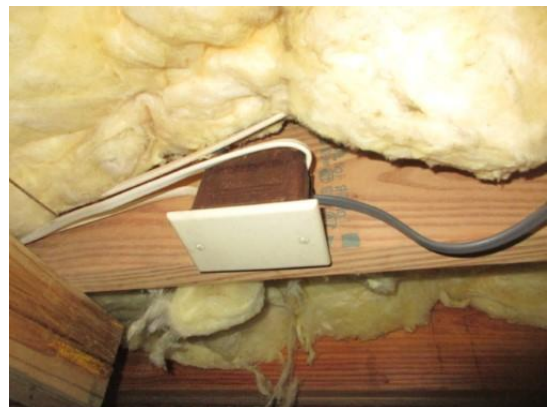
- E.5 **SAFETY \$\$** #14 and #12 wire is connected together especially in this crawlspace. This circuit is wired through a 20 amp breaker, which does not protect this wiring. A qualified electrician should evaluate and repair this and all other connections.

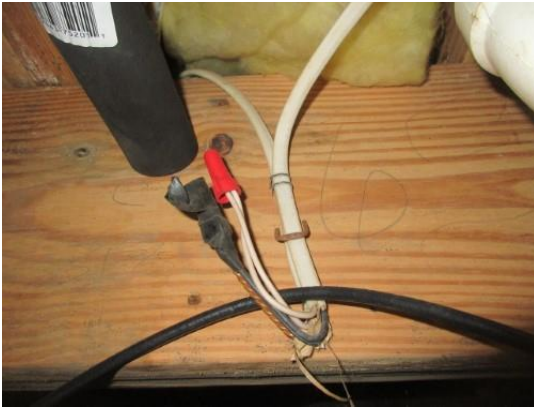
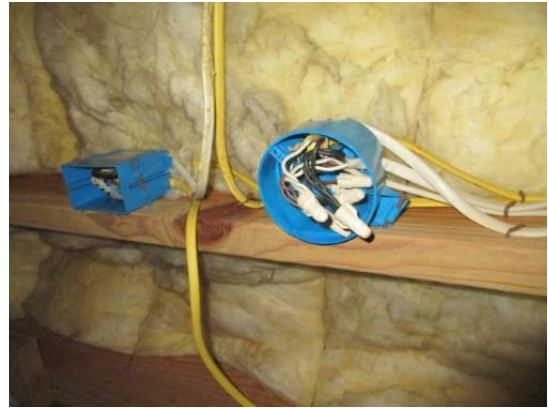
- E.8 **SAFETY \$\$** Open junction boxes and/or open wire splices were observed in the crawlspace. See examples below.

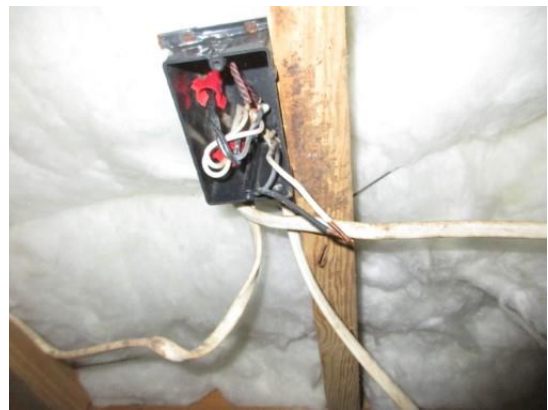
- E.9 **SAFETY \$** Wires in a junction box at the left rear of the crawlspace are not properly terminated.

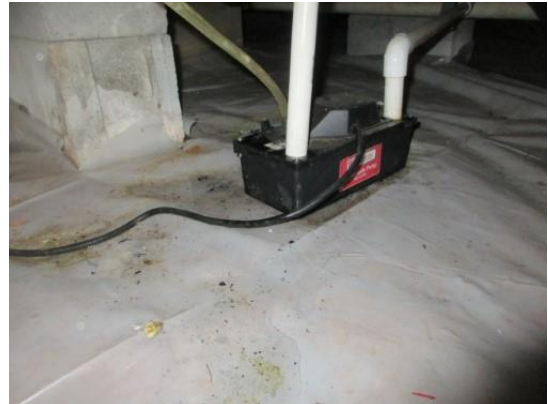
- H.1     \$\$ The condensate pump did not operate.

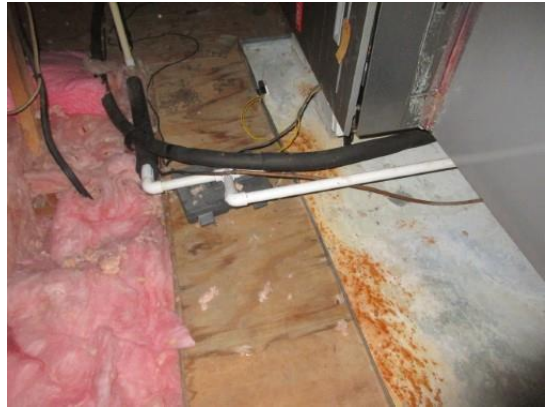
H.4 \$ Not all of the primary condensate drain is insulated. This drain will tend to sweat and drip onto the attic floor.

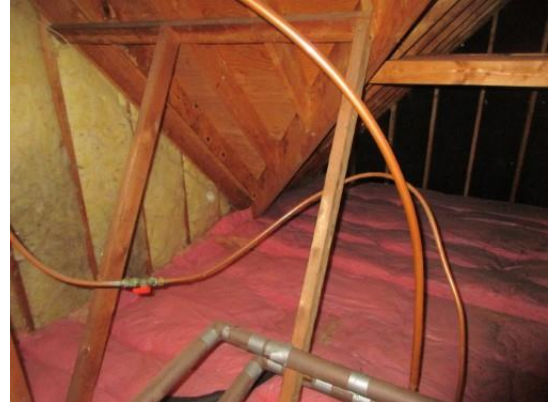
- P.1 **SAFETY \$** Copper gas piping in the attic and crawlspace is not marked. See example in photo.

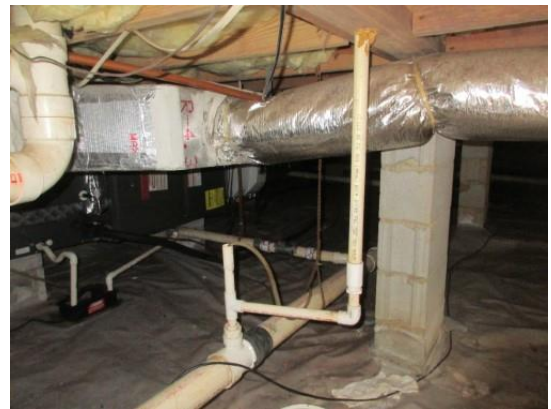
- P.2 **\$\$** There are openings (probably to drain the water heater pan, and a condensate drain) in the waste pipe at the front left of the crawlspace which will allow escape of poisonous sewer gasses into the crawlspace/house.

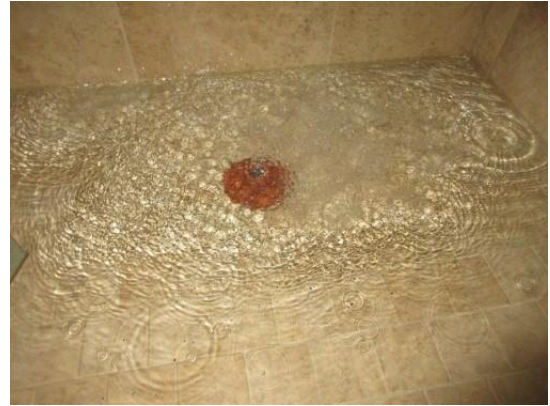
- a    Some of the floor beneath/around the shower tested as being wet (60%) with an electronic moisture meter, indicating active leakage possibly due to a faulty pan beneath the shower tile. This leakage occurred after a half-hour ceramic tile shower test using a special inspection tool for this purpose. Stains indicate this shower has leaked in the past. No significant damage was observed in this area. See related remarks in the Crawlspace section.
- b    The shower door rubs its jamb/adjoining glass when closing.
- c    Weather stripping at the bottom of the shower door is damaged.
- d    The tub faucet is loose.
- e    The right sink drains slowly.
- f    The toilet bowl is loose at the floor.

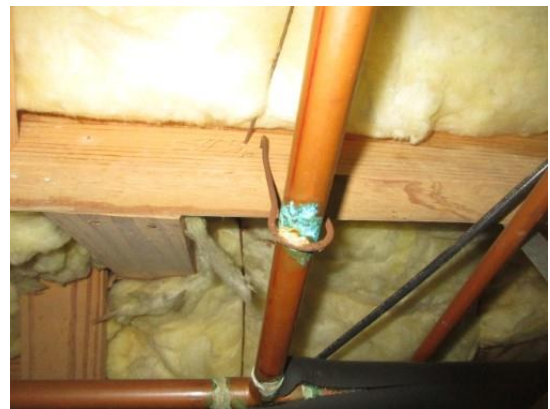
- P.8     **\$** Steel hangers have been used to support the copper water piping and corrosion is occurring where these dissimilar metals touch. See example in photo. Extent of corrosion is not known.

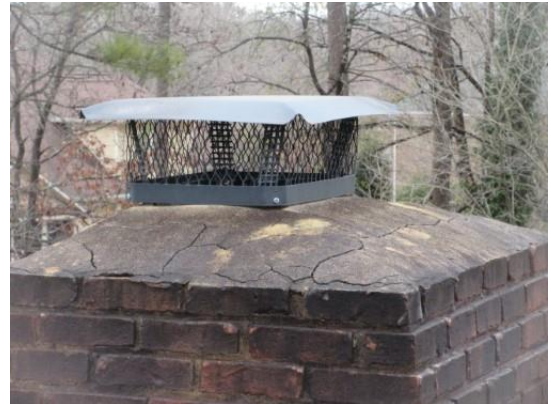
- F.1.   \$ Mortar has deteriorated from between some of the brick in the outdoor firebox.
- F.2.   \$ The lever is not connected to the outdoor fireplace damper.
- F.3.   \$\$ The masonry cap, installed at the top of the front chimney between brick and flue, has cracked and deteriorated. See example in photo. Repair to reduce water seepage between the brick and flue and behind roof flashings.

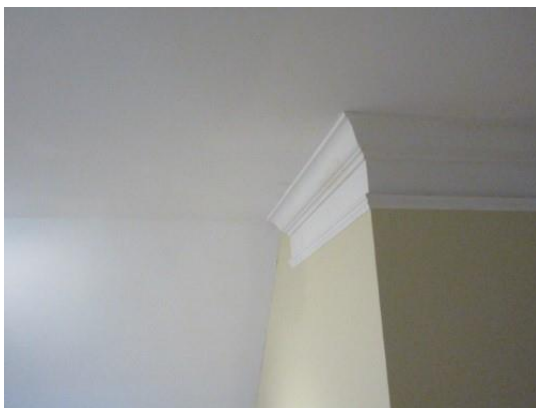
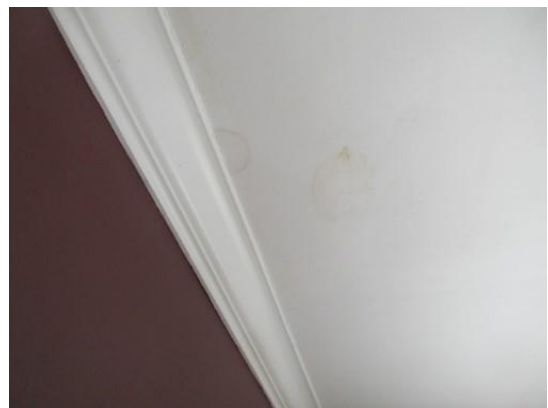
- I.1 **Dig Deeper** Moisture stains on the ceiling especially at the kitchen, front left sitting room, and left skylight tested as being dry with an electronic moisture meter. See examples in photos. Stains on the ceiling around the front chimney were out of reach to test. See related remarks in the Attic section. Recommend asking the owner if there has been leakage and if the leak(s) has been effectively repaired. Recommend monitoring for continued leakage and repair as needed. There may be concealed damage.
