# Daniel Whitten Inspections, LLC

## **BUILDING INSPECTION REPORT # XXXX**

## BUILDING INSPECTION REPORT #1098

Address of Building to be Inspected: Main Street, Upstate, SC

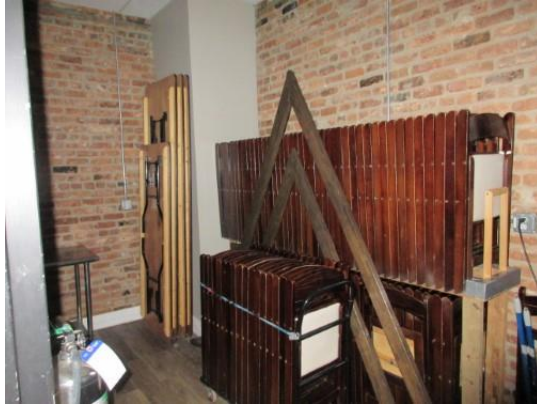
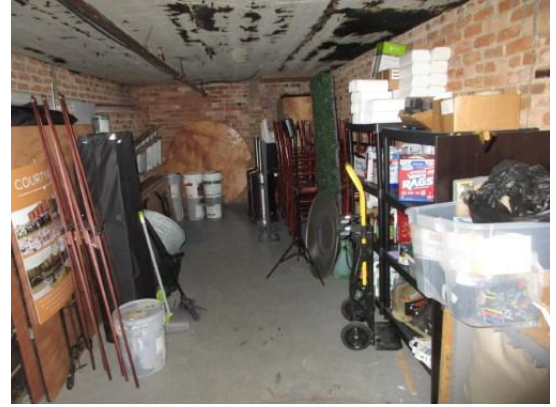
- X.e Readily visible components appear to be in fairly typical condition for the age of the building. See examples in photos. Many personal stored items, furniture, wall and window hangings, etc., obstruct full viewing of this area. This area should be viewed when the items are removed. Conditions in these areas are not known and are specifically excluded from this inspection and report.
