# Daniel Whitten Inspections, LLC

## **BUILDING INSPECTION REPORT # XXXX**

Inspection Address:

Fortune Drive

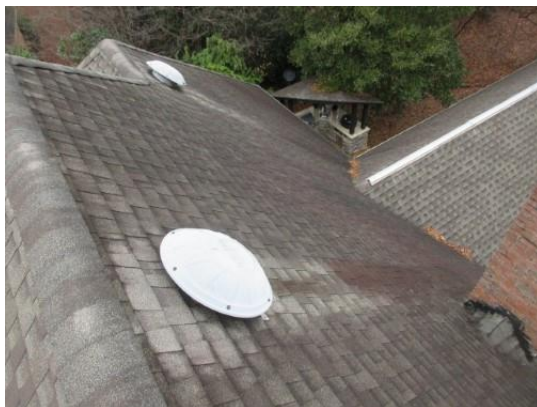
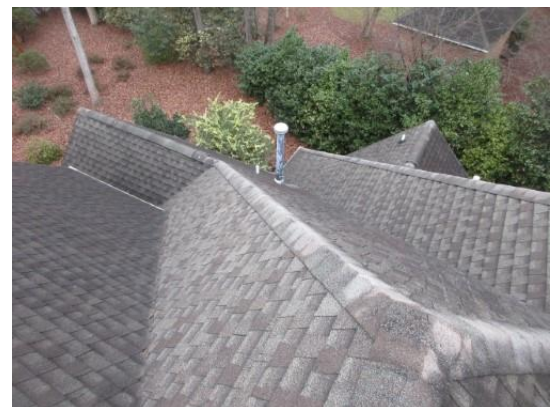
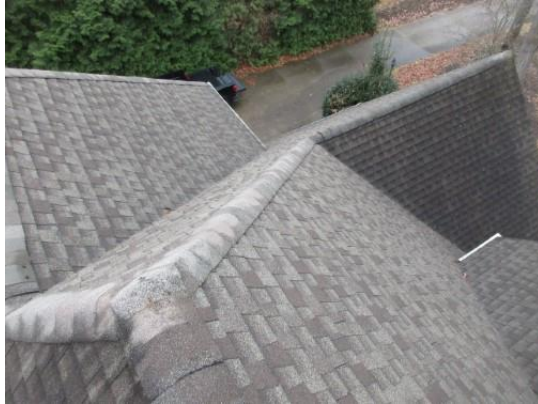
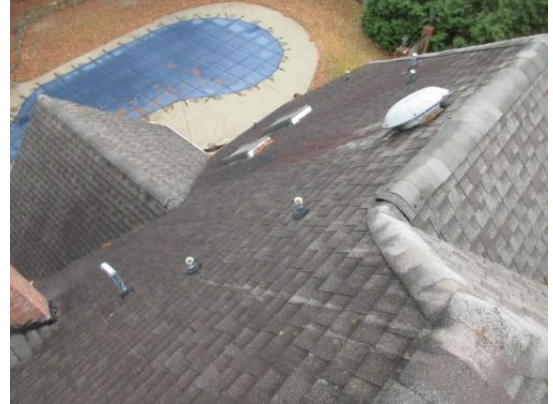
- R.a There is one layer of shingles where checked.
- R.b Viewing the roof in this manner (non-invasive and non-destructive) will probably not lead to discovery of all flaws in roofing materials and installation. Most flashings are not fully visible, and some areas which should be flashed may not be flashed due to manner of installation or obstructions. Condition of flashings and flashed areas are not known and are specifically excluded from this inspection and report. There may be and are often leaks which are not discovered, especially if it is not raining or hasn't rained in the past few hours; especially if leaks occur only in combination with certain wind conditions; especially if leaks occur only after extended periods of rain; especially during snow or ice; especially when there is accumulated debris. Recommend checking attic areas for leaks during rain.

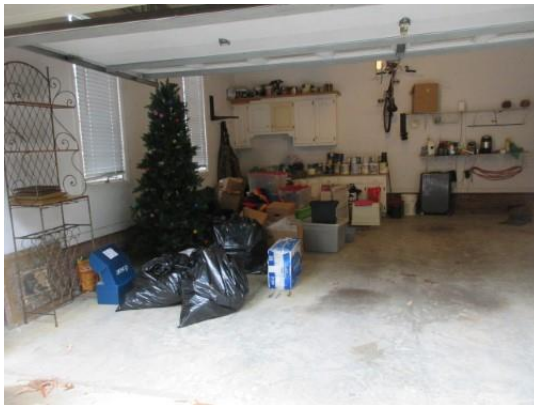
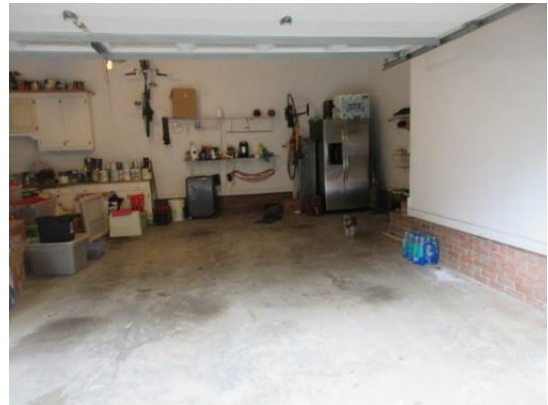
T.a Stored personal items and/or furniture obstruct much of the walls and floor from view. See examples in photos. There may be damage and/or faults not visible due to the obstructions. This area should be viewed for damage and faults as soon as the obstructions have been removed. Conditions in this area are not known and are specifically excluded from this inspection and report.

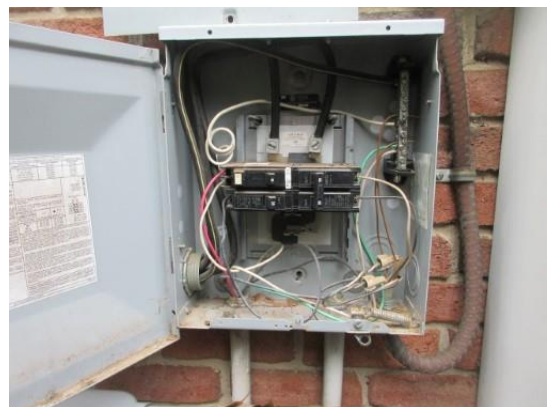
- E.a No faults were observed in the outdoor main electrical panel.

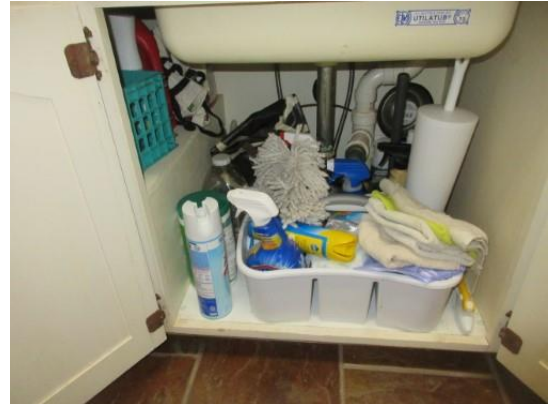
- P.b Stored personal items obstruct viewing the areas beneath kitchen and/or bathroom sinks. See example in photo. There may be leakage and/or damage not visible due to obstructions. View these areas for problems when the items have been moved and repair as needed.

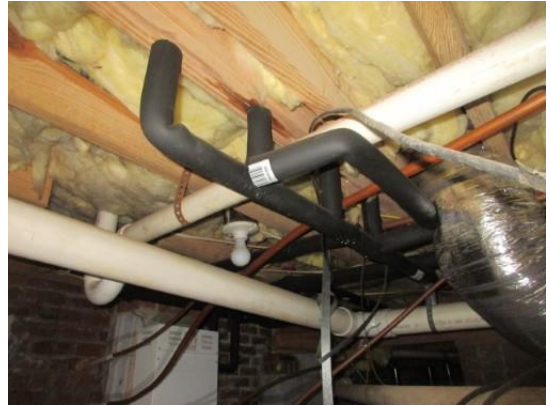
P.i Some of the water piping is insulated and is not visible for inspection. See example in photo. Its condition is unknown and is specifically excluded from this inspection and report.
